STRENGTHENING OF KEYED LONGITUDINAL
CONSTRUCTION JOINTS IN RIGID PAVEMENTS

R. W. Grau

Army Engineer Waterways Experiment Station

TECHNICAL REPORT NO. AFWL-TR-72-174

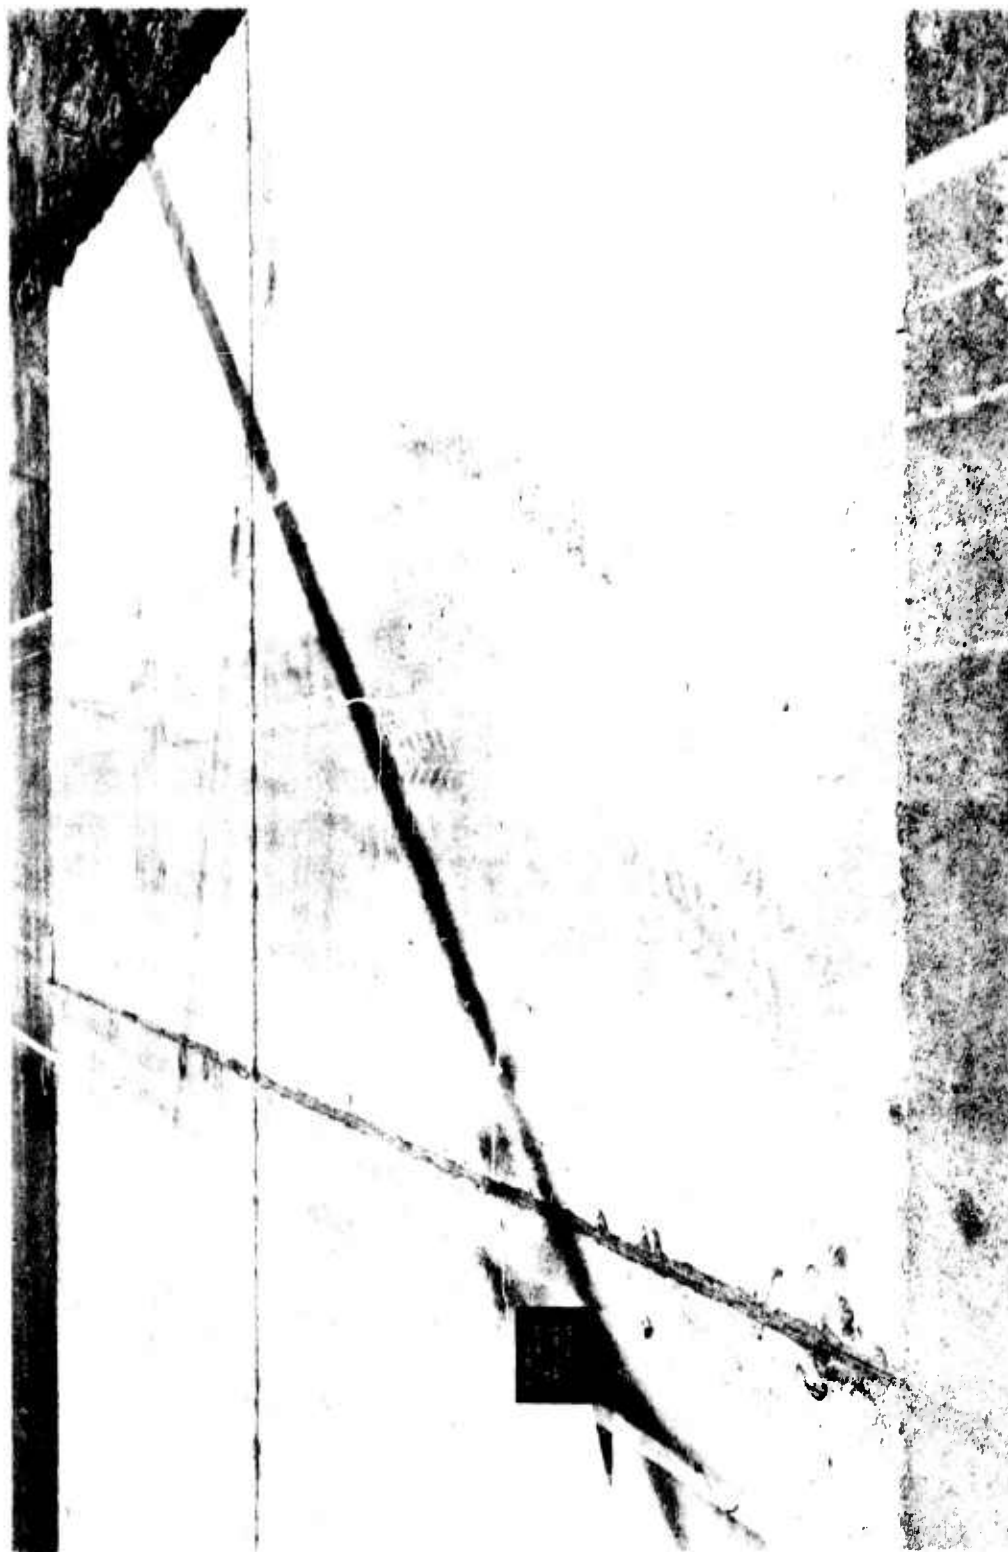
After one pattern of test traffic (16 coverages), flaking and spalling were evident along the edges of the existing cracks. Initial cracking due to test traffic occurred in the southwest slab at about 54 coverages. This cracking consisted of a 25-ft-long longitudinal crack about 10 ft south of the longitudinal construction joint and a transverse crack in about the center of the slab extending from the construction joint to the longitudinal crack. Between 54 and 144 coverages, cracks developed very rapidly in the two south slabs of the item. After 144 coverages, the surfaces of the southwest and southeast slabs were subdivided into 7 and 4 pieces, respectively, as shown in figure 28. Although the southwest slab met the shattered-slab failure criterion after 144 coverages, traffic was continued because the longitudinal construction joint was performing satisfactory.

Figure 28. Item 1, 360-kip, 12-wheel-assembly lane after 144 coverages.

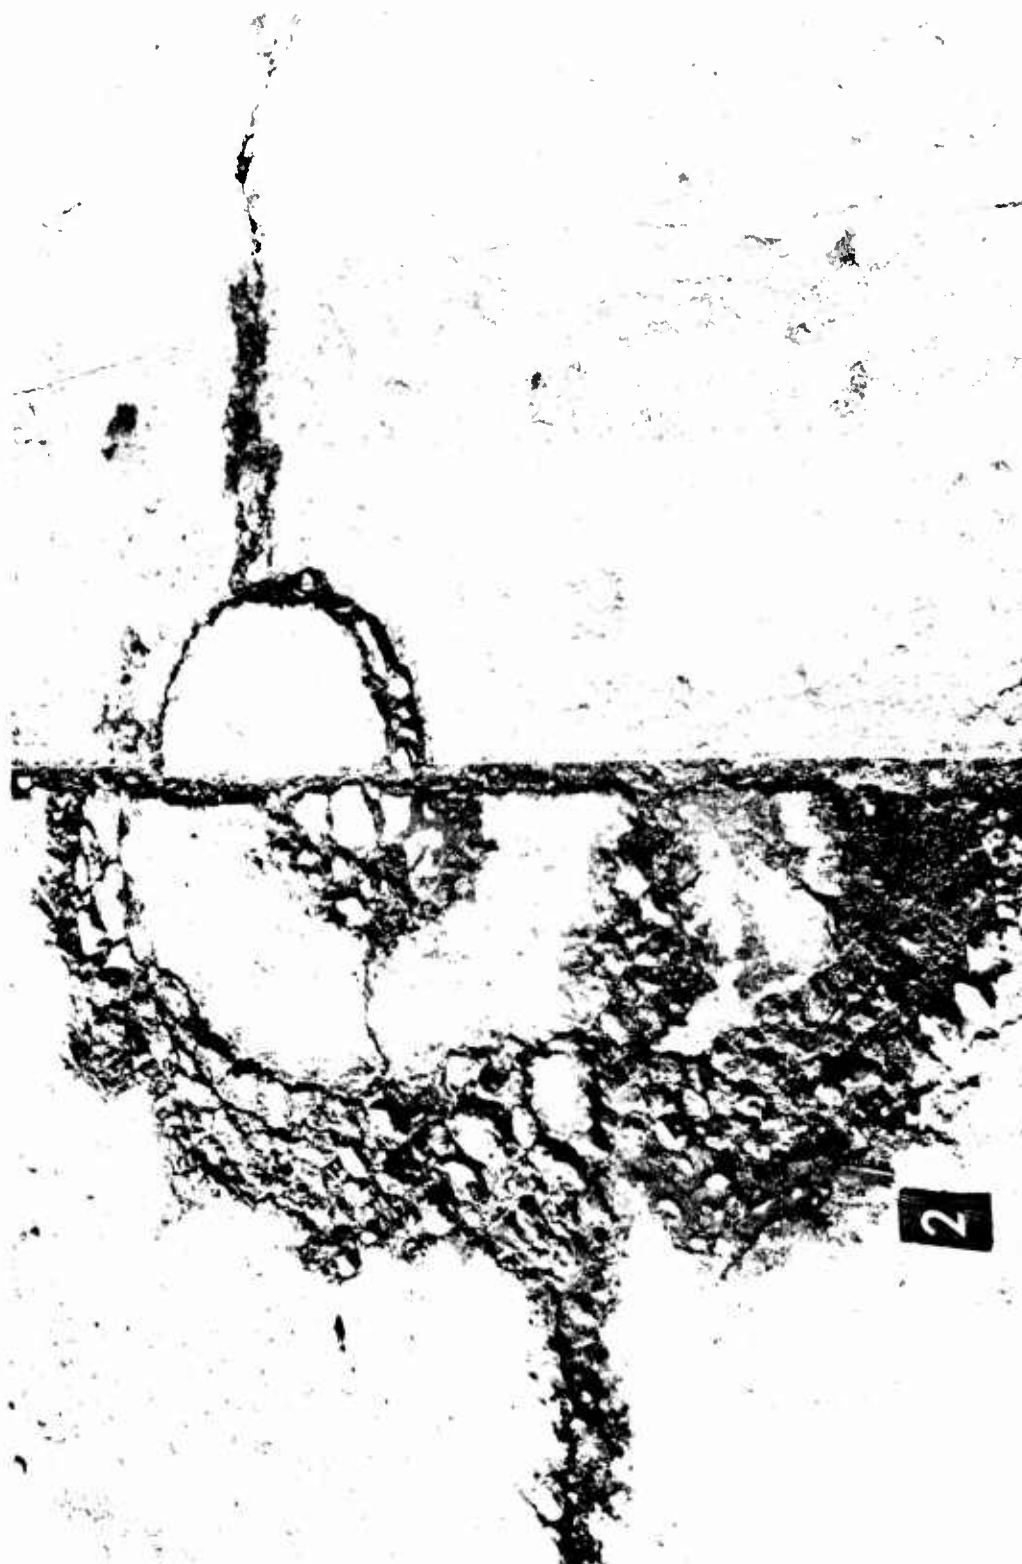
Figure 40. View of under-grouted joint in item 2, 360-kip, 12-wheel-assembly lane after 816 coverages.

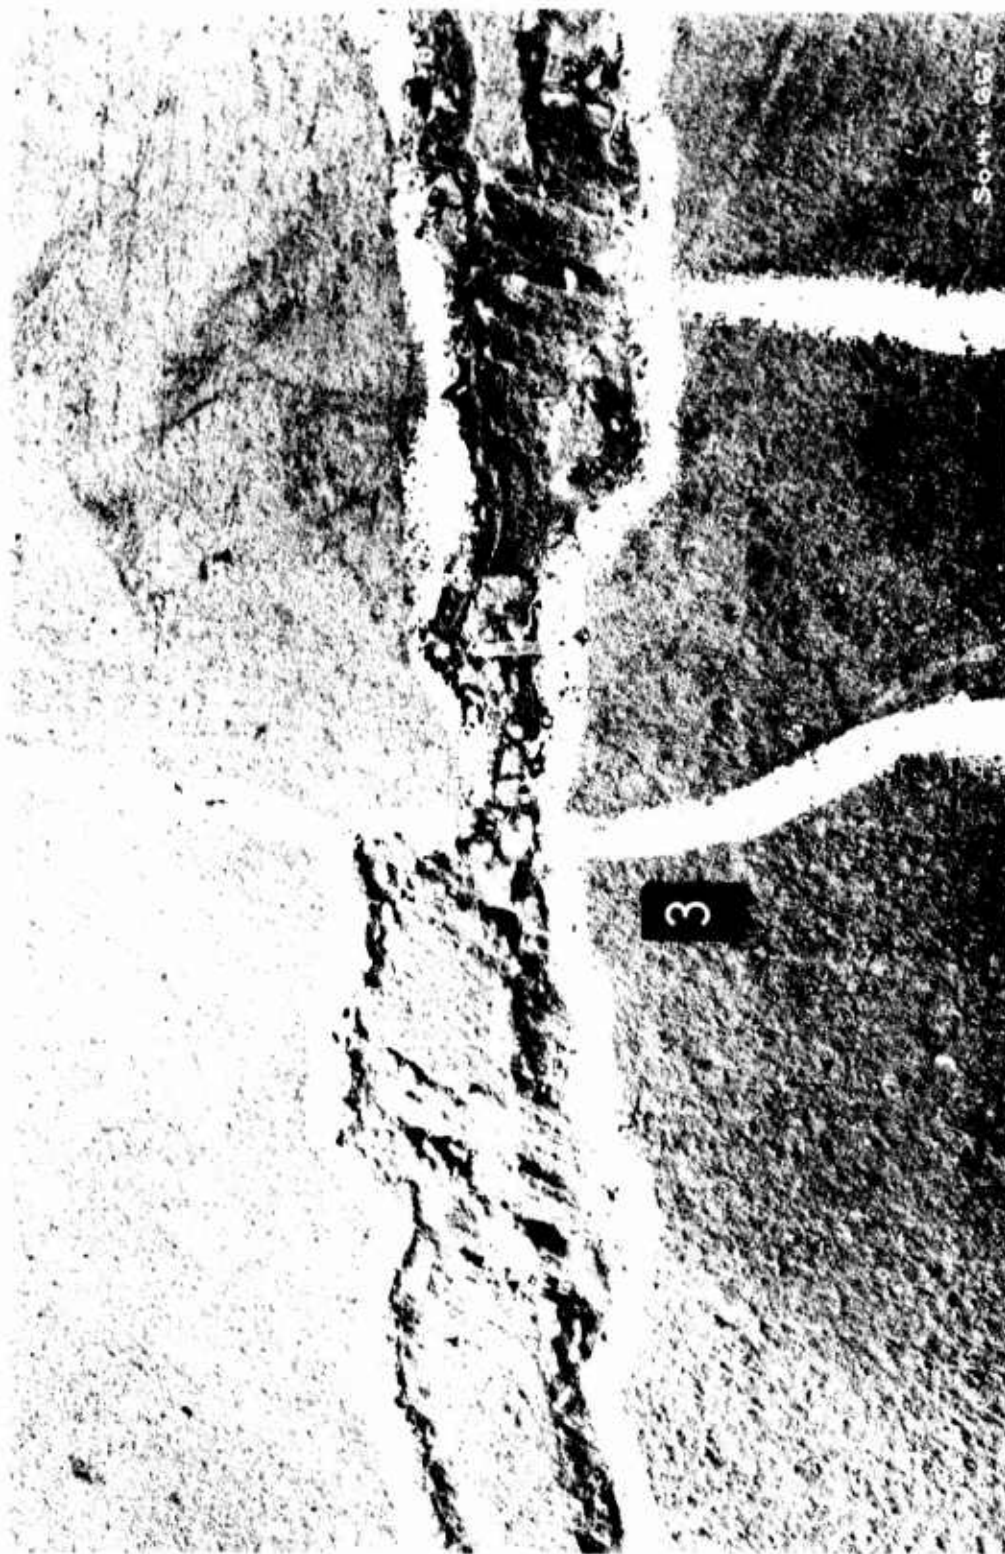
Figure 49. Spalling and flaking along cracks in item 3, 360-kip, 12-wheel-assembly lane after 504 coverages.
